EXISTING BUILDING: LIMITED REMODEL

Building Repair: FACILITY IMPROVEMENTS PER 2016 ASSESSMENT BY ALTUSWORKS

CLARENDON COMMUNITY CENTER PARK

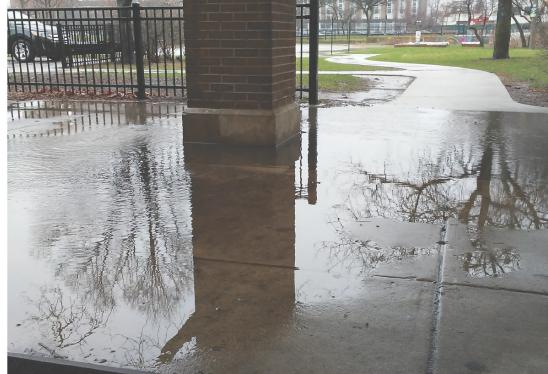
EXISTING FLOODED BUILDING ENTRY

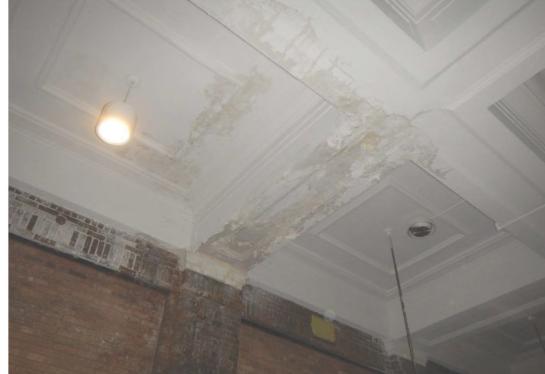
EXISTING MULTI-PURPOSE ROOM WATER DAMAGE

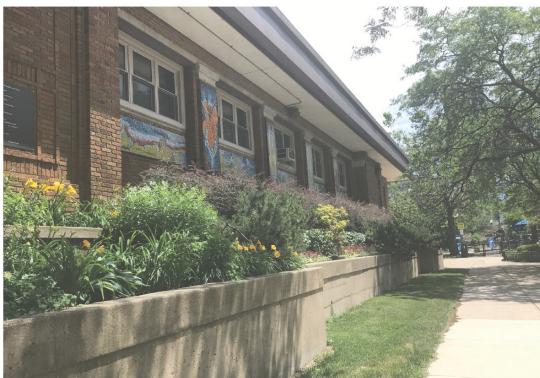
EXISTING LEAKING PLANTER
